UNCLASSIFIED

THIS PAGE IS UNCLASSIFIED

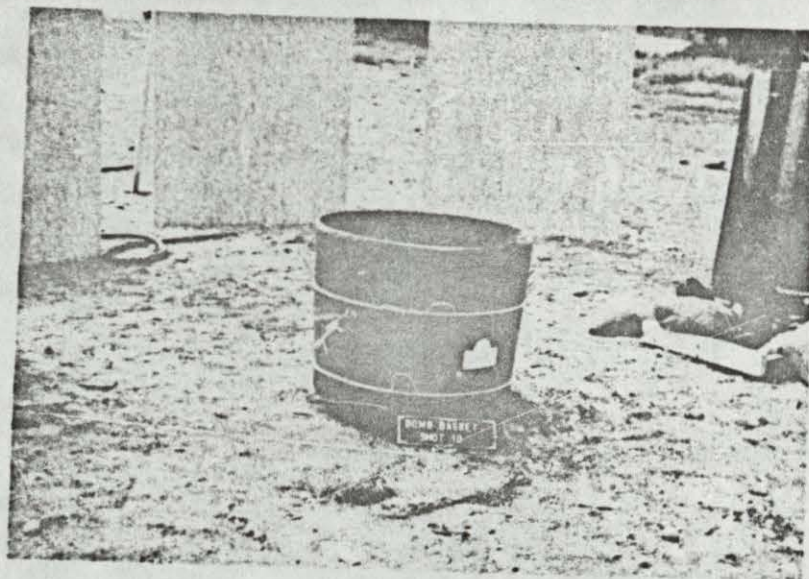
Figure C-12. Results from black powder-filled pipe bomb. Very little damage was done to the basket and no fragments penetrated the walls. Note the rubber rim in the background.

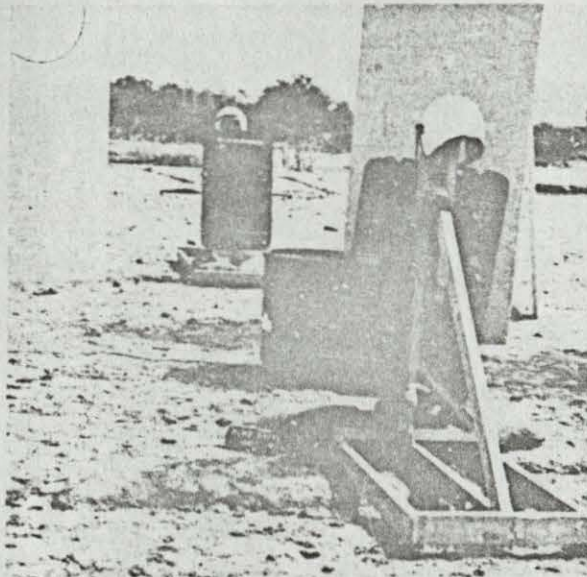
Figure C-14. When testing fragmenting explosive devices, personnel helmets, body armor, and shields were placed on stands at distances of 6 and 12 feet from the basket.

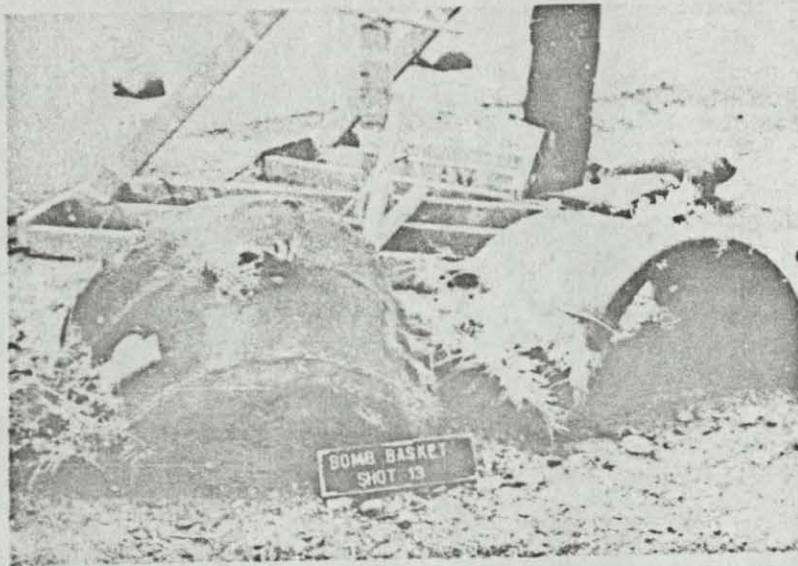
Figure C-25. The exterior of the basket shows the exit holes made by the end caps. The wall condition indicates relatively little blast pressure damage, but extensive destruction from high velocity fragments.

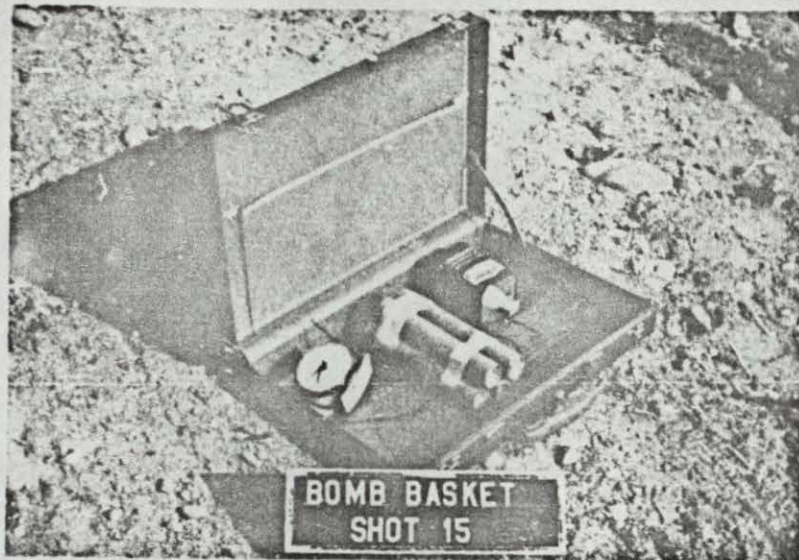
Figure C-35. An improvised explosive device (IED) was constructed using an attache case, a 6-volt dry cell battery, a wind-up alarm clock, several feet of wire, and commercial dynamite. Although primarily a blast device, incidental fragmentation results from the case hardware, battery, and clock.

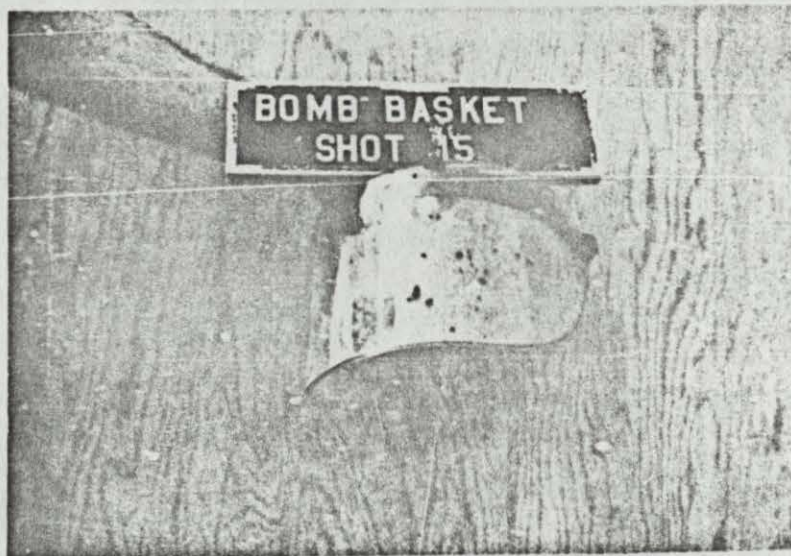
Figure C-40. The face protector from 6 feet shows a splattering of carbon material from the dry cell battery. The perforation was caused by Shot 13.

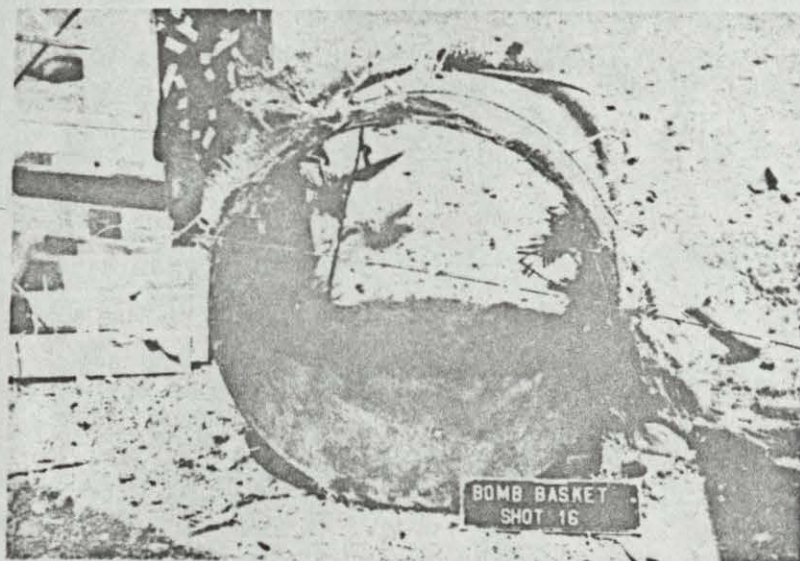
Figure C-42. A view from the top of the basket after the detonation of the 10-stick IED shows little fragment damage.

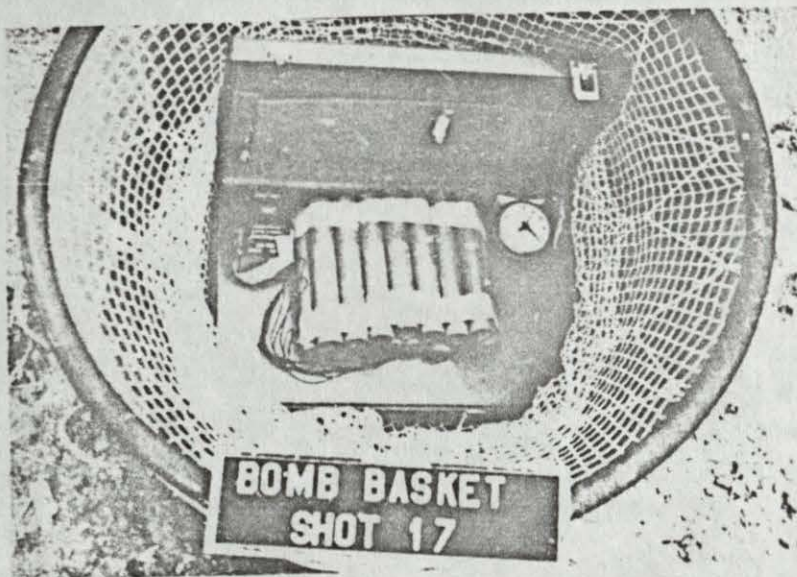
Figure C-46. A 15-stick IED was prepared for Shot 17.

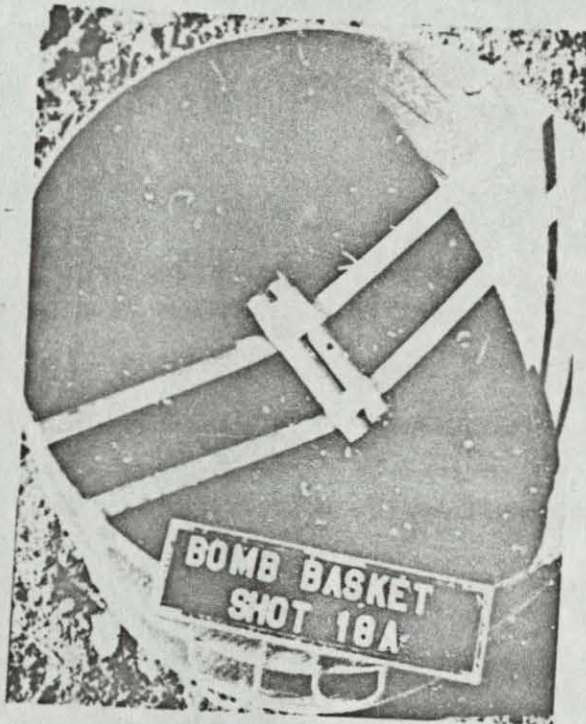
Figure C-51. Subsequent charges were placed in the basket by suspending them with paper masking tape.
